**Appointed examiner's audit of One-Off Exceptional Event Claim  
Western Power Distribution (South Wales)  
132kV incident – Swansea North to Ammanford  
07 November 2015**

Title: Western Power Distribution (South Wales) - Audit of One-Off Exceptional Event Claim - 132kV incident - Swansea North to Ammanford - 07 Nov 2015

Reference: ep/Ofgem/WPD(SWa)/07 Nov '15

Date: 28 October 2016

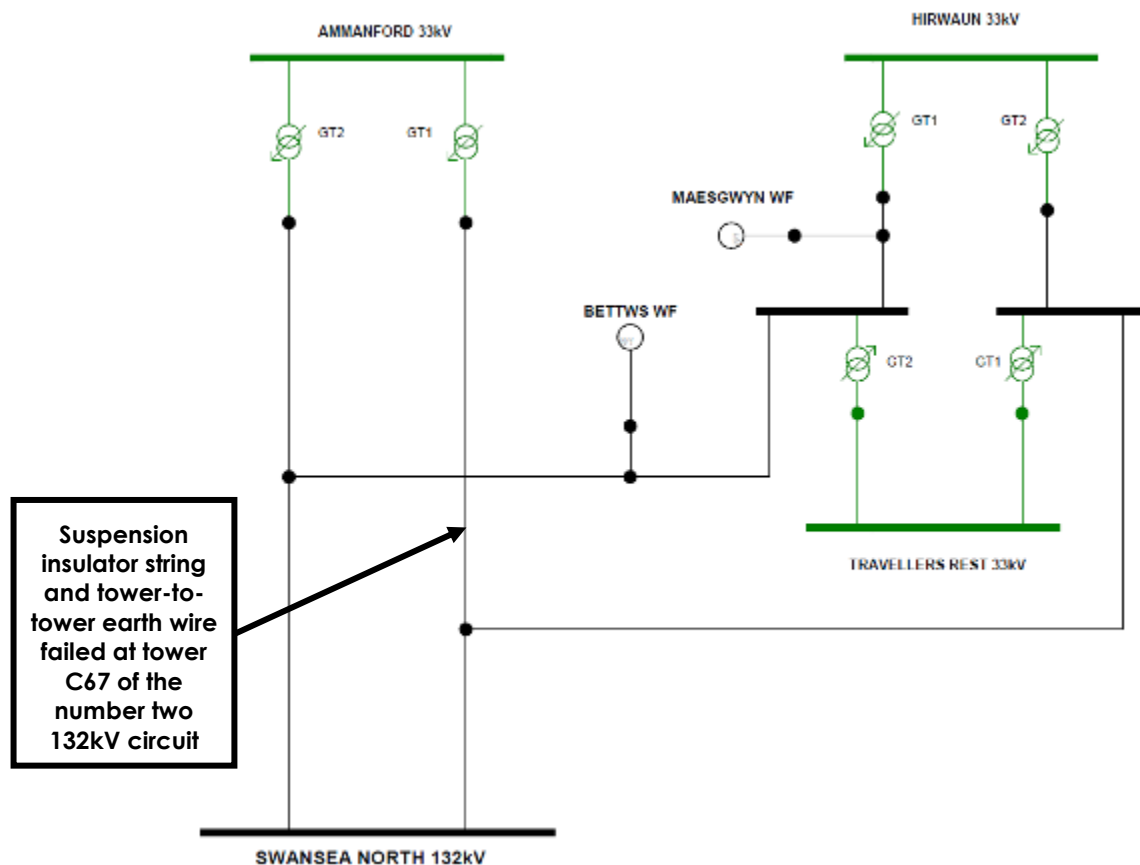
Figure 1 – Simplified Network Diagram of WPD's 132/33kV distribution system affected by the incident

25. Taken from WPD's SoF, a simplified view of the section of WPD's 132/33kV distribution system affected by this event is shown in Figure 1.
