## **Appendix 1**

# **Warehouse Condition Report**

**August 2020**

This report contains a summary of findings from site visits to strategic stores at:  
SSE Port Caroline, Dundee  
SSE Tealing Substation,  
SSE Fanellen, Beaulieu.  
The visits were conducted on 15<sup>th</sup>/16<sup>th</sup> July 2020.

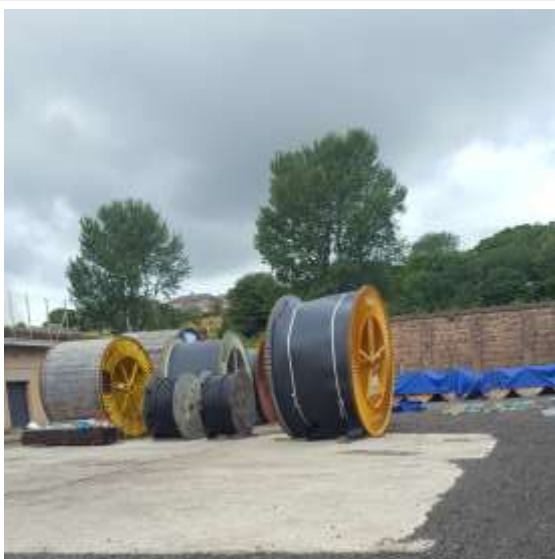
**Figure 8: Carolina Port - Degraded Packaging of Stock Held Inside**

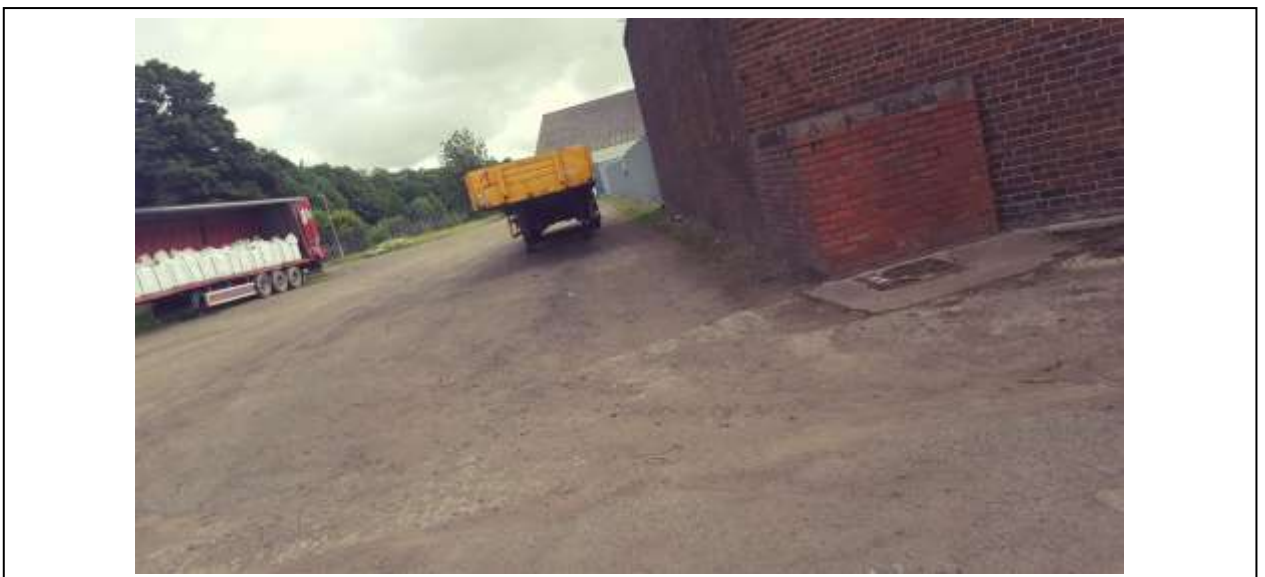
**Figure 12; Carolina Port - Evidence of Flooding**

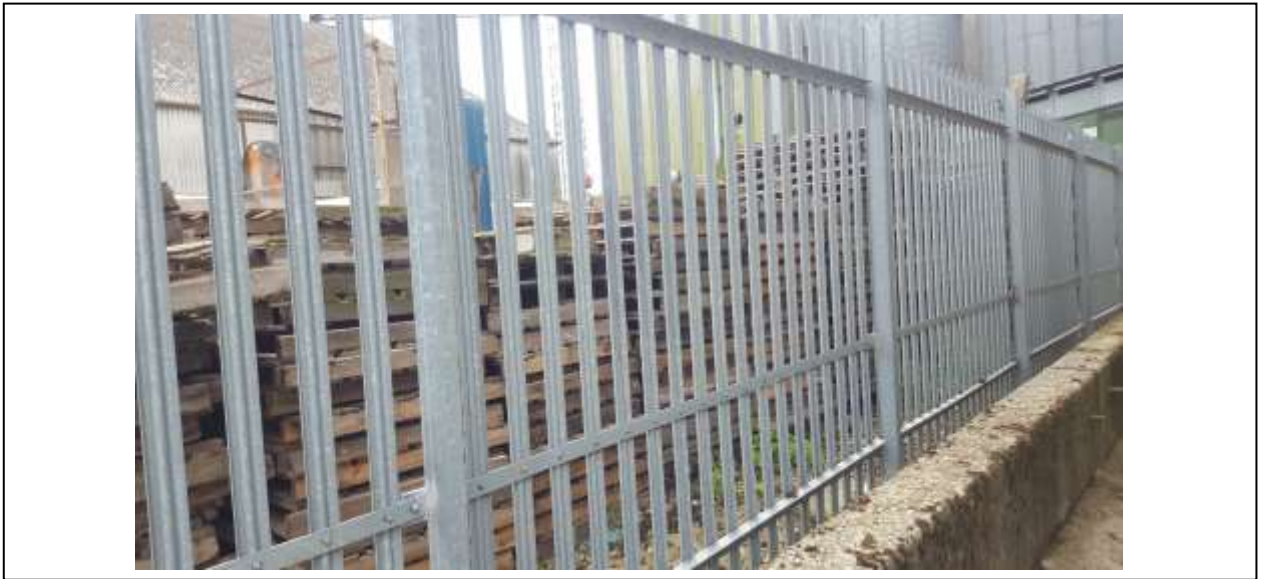
**Figure 15: Carolina Port - Proximity of Grain Dryer**

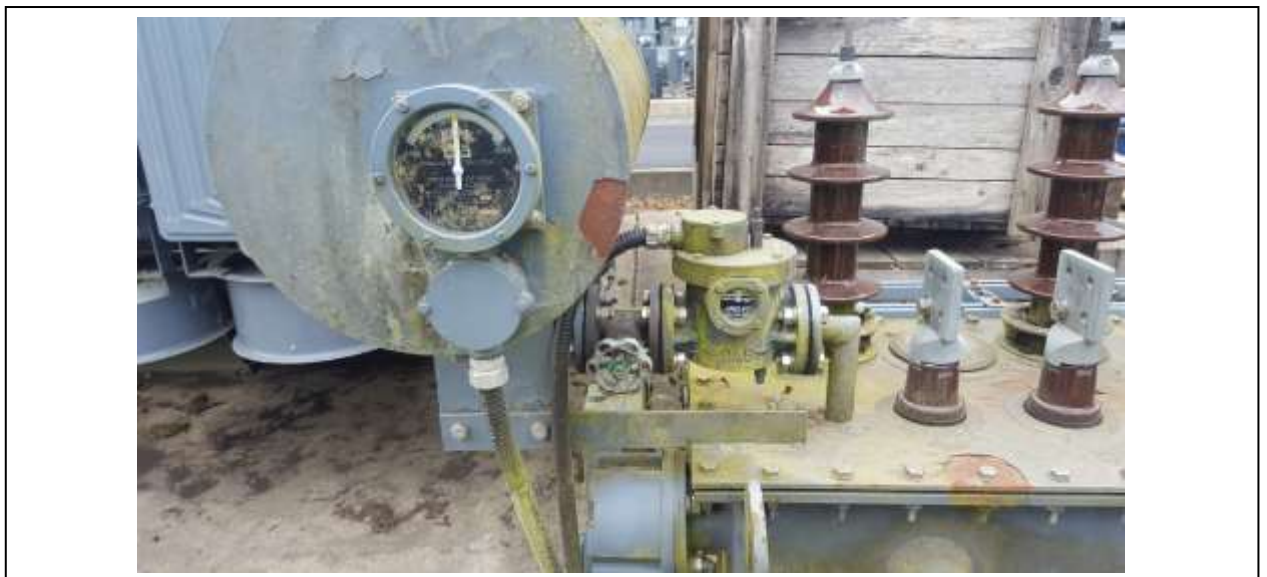
Constant maintenance of the area is required to remove pine needles and pine cones. There is evidence of moss and lichen growth on equipment. (See Figure 21 & 22).

**Figure 22: Tealing - Lichen Accumulation**

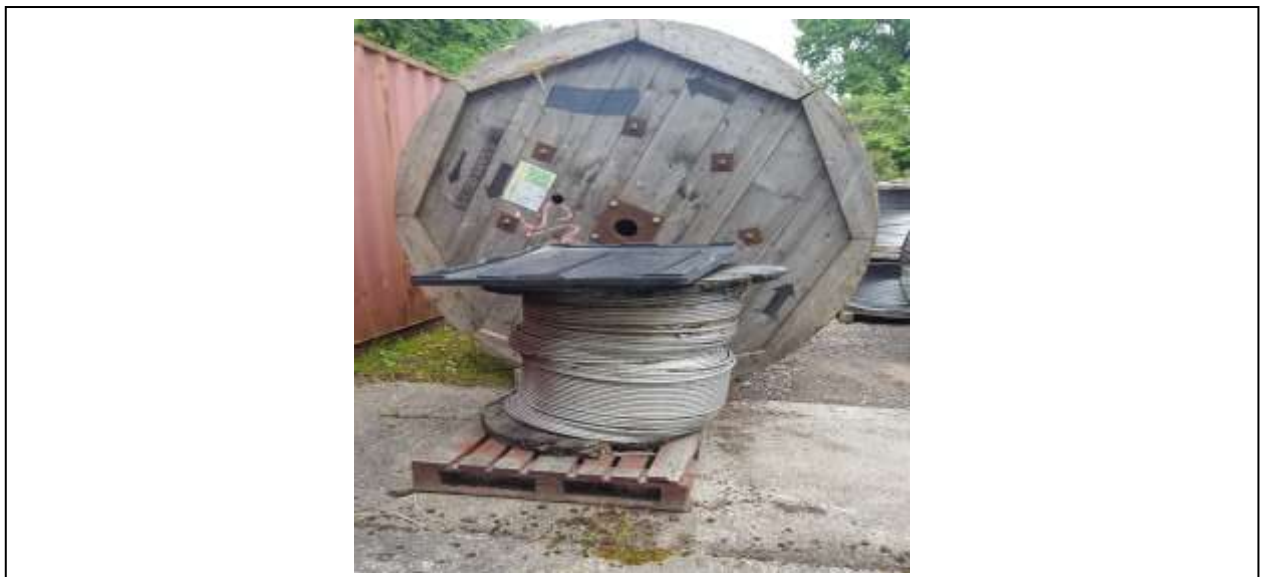
Lack of internal space has led to a large amount of equipment being stored outside. Approximately a third of the yard area is hard-core, leading to significant dust issues in the summer and making it unusable during icy winter periods of time, when hardpacked snow and ice leave the area dangerous for operations (See Figure 28).

**Figure 28: Fanellan - External Reel Storage**

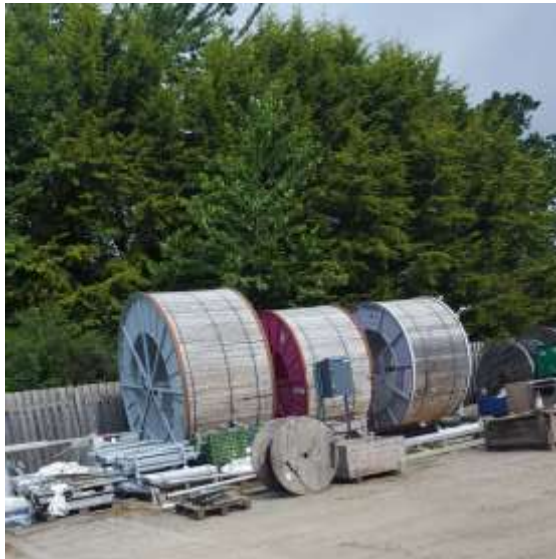
**Figure 29: Fanellan - External Storage and Fence**

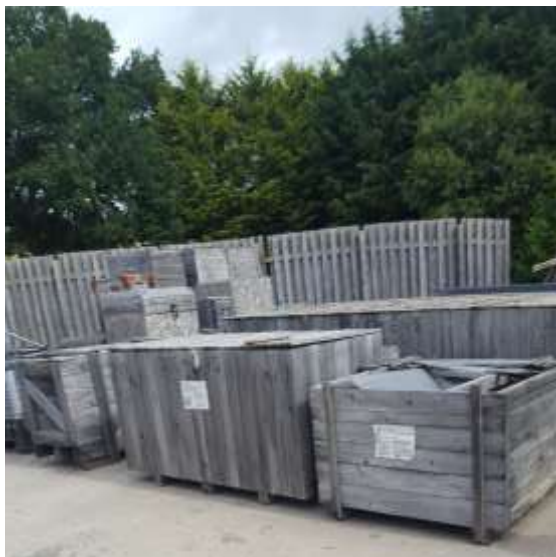
**Figure 30: Fanellan - Fence**
