Energy Companies Obligation (ECO) Technical Monitoring Report

December 2015

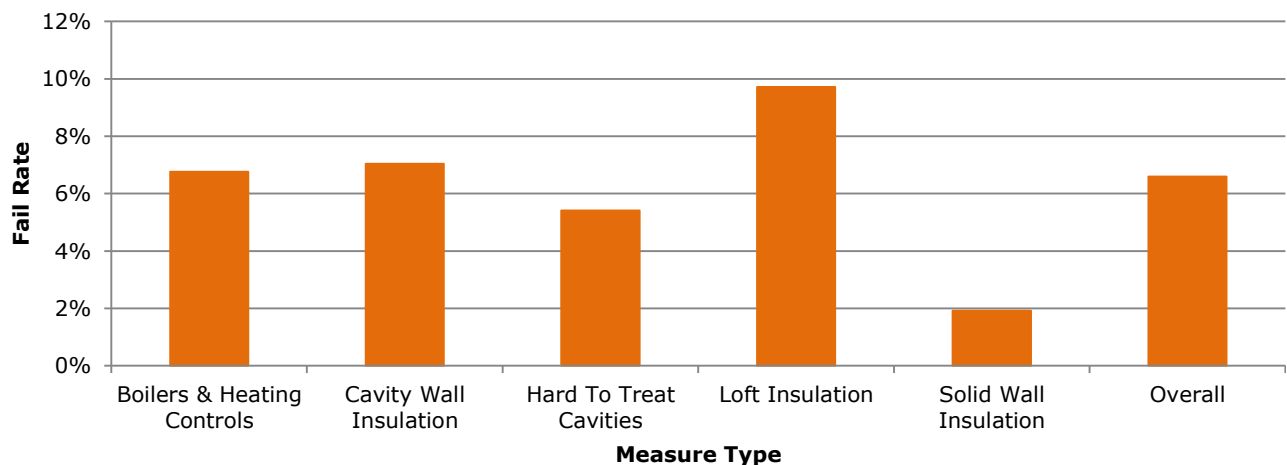
Figure 2: Scoring failure rates for the five most common measure types notified under ECO, along with the overall fail rate for all measures.

The high scoring failure rate for loft insulation was largely related to fails on questions regarding the thickness of existing loft insulation. Over the course of the ECO1 obligation we became aware of concerns

regarding the claimed depths of existing loft insulation and the savings claimed on those measures installed. Together with suppliers we investigated a number of these measures to establish whether claimed scores were accurate. Where this was not the case, suppliers were required to rescore the measures and, if appropriate, take anti-fraud action. Based on our learnings, we introduced new evidencing requirements for loft insulation and enhanced our guidance on scoring these measures for the ECO2 obligation period. We also engaged with energy companies, who conducted their own internal audits to ensure that loft insulation was scored as accurately as possible.
